Transport  
Canada

TP 185E  
Issue 2/2007

# AVIATION SAFETY LETTER

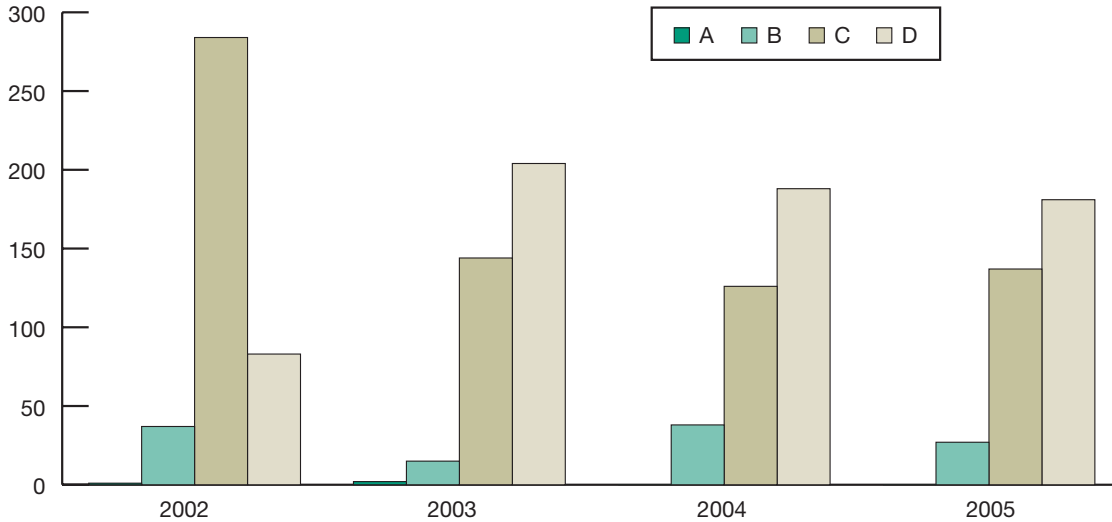
*All Runway Incursions by Severity*

Runway incursions are classified as to the severity of the risk. Category A events are ones of extreme risk with instantaneous action required to avoid a collision. Very few runway incursions are Category A. In Category B incursions, there is a significant potential for collision. For example, action is required to prevent a vehicle entering a runway where an aircraft is cleared to land. Category C is similar to B, but there is ample time and distance to avoid a potential collision. Category D describes situations where there is little or no chance of collision. For example, this might be used to classify a situation where a vehicle proceeds onto a runway without permission, but there are no aircraft landing or taking off. Factors such as weather, speed of the involved aircraft, and time to take action are considered in a matrix in order to determine the risk. Chart 1 shows runway incursions in terms of the severity of the risk.

Severity	2002	2003	2004	2005
A	1	2	0	0
B	37	15	38	27
C	284	144	126	137
D	83	204	188	181
<b>Total</b>	<b>405</b>	<b>365</b>	<b>352</b>	<b>345</b>

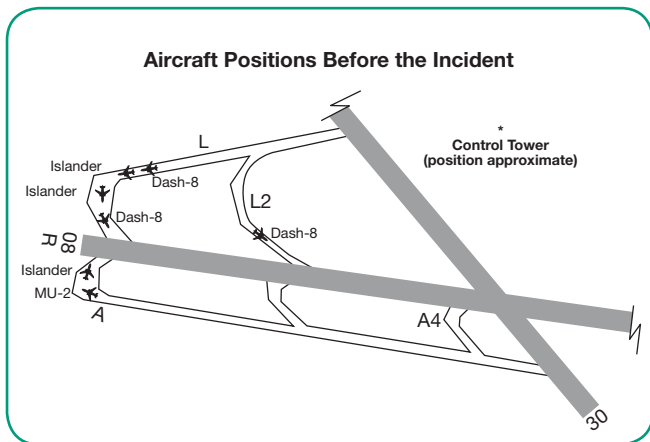
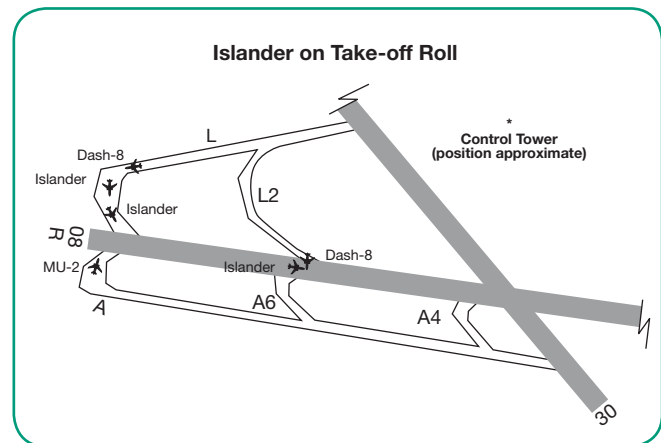
The Dash-8 crew at L2 apparently acknowledged their clearance to position; however, it was blocked by another transmission. The Dash-8 at L2 began taxiing toward Runway 08R, while looking ahead for the Islander it was to follow—which was in fact behind it.

*Analysis*—Following the routine pre-shift review and briefing, the controller was not aware that Taxiway L2 was open; on the controller's two previous night shifts, L2 had been closed for maintenance. When the controller scanned the departure flight progress strips for the taxiway designators assigned by the ground controller, it was not recognized that the digit "2" was partially obscured by other information for the one departure on Taxiway L2.

The airport control tower is equipped with airport surface detection equipment (ASDE). This ground surveillance radar system displays targets on the airport, but it has some inherent limitations and some unresolved technical anomalies. The tower controller did not rely on this system, and did not associate a target on Taxiway L2 with the Dash-8, or monitor the ASDE when the Dash-8 was cleared to position behind the Islander.

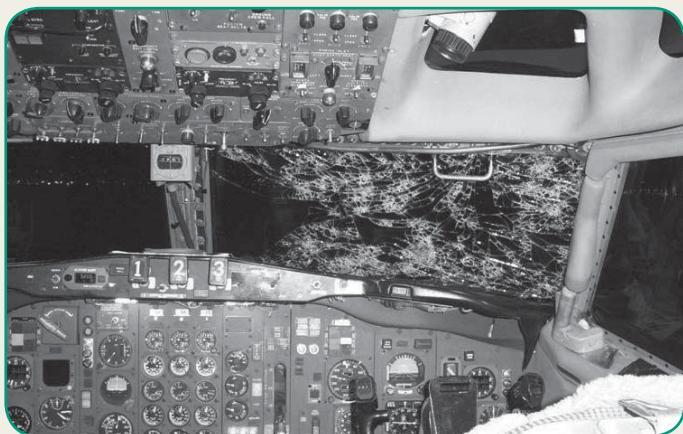
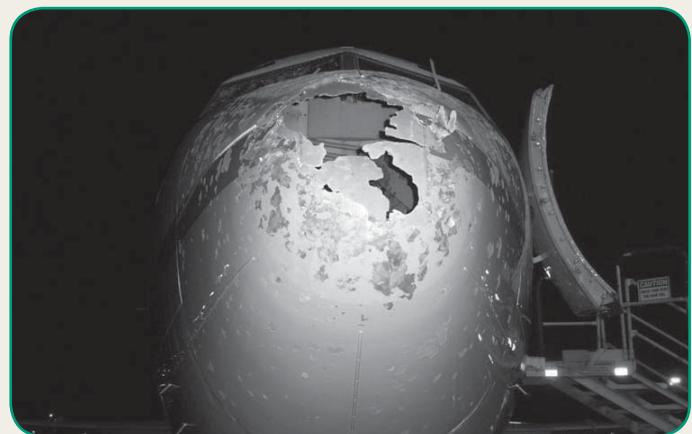
## Hail Damage...

While in cruise at FL 300 after departing Calgary, Alta., this Boeing 727 sustained extensive hail damage after an encounter with a severe thunderstorm. In addition to the damage shown, wing leading edges, engine inlets and landing lights lenses were also damaged. The aircraft returned to Calgary for an uneventful landing and was later repaired.

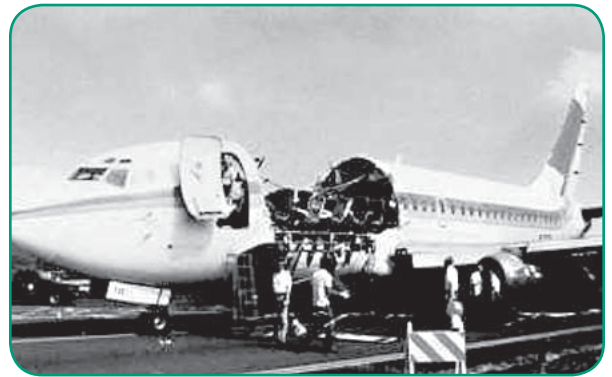
*April 28, 1988: Aloha Airlines flight 243, Boeing 737-200 near Maui, Hawaii, fuselage upper crown skin and structure separated in flight.*

While the Aloha Airlines accident was not the first ageing airplane fatal accident, it was the one that brought the issue to public attention. The Boeing 737-200 was a high-cycle aircraft that suffered a partial in-flight disintegration in which an 18-ft crown section of the fuselage was torn apart in flight. The accident investigation revealed the presence of small cracks at multiple rivet locations in a disbanded lap joint, which were sufficient in size and density to cause the accident. This phenomenon is referred to as widespread fatigue damage (WFD).

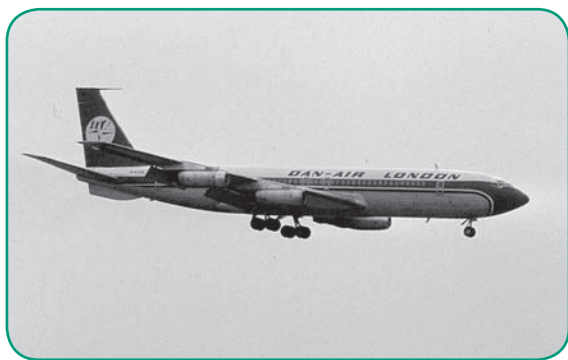
A Dan-Air Services Boeing 707-300C, similar to the aircraft that crashed near Lusaka, Zambia, on May 14, 1977.

Historically, we may look back to 1977 for what could be argued as the first ageing-airplane related accident; a Dan-Air Services Boeing 707-321C that crashed on final approach in Lusaka, Zambia. The airplane, engaged in a non-scheduled international cargo flight, happened to be the first aircraft off the 707-300C series convertible passenger/freighter production line. On approach, the airplane pitched rapidly nose down, dived vertically into the ground from a height of about 800 ft, and caught fire. The accident was determined to be caused by a loss of pitch control following the in-flight separation of the right-hand horizontal stabilizer and elevator as a result of a combination of metal fatigue and inadequate fail-safe design in the rear spar structure. Shortcomings in design assessment, certification, and inspection procedures were contributory factors. A post-accident survey of the 707-300 fleet worldwide revealed a total of 38 aircraft with fatigue cracks present in the stabilizer rear spar top chord.

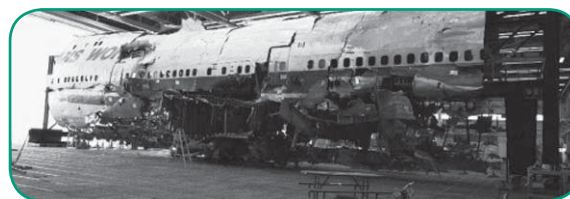
July 17, 1996: Trans World Airlines flight 800, a Boeing 747-131, in-flight break-up over the Atlantic Ocean, near East Moriches, N.Y., 230 fatalities.

catastrophic. That all changed on July 17, 1996, when Trans World Airlines (TWA) flight 800, a 25-year old Boeing model 747-131, was involved in an in-flight break-up after takeoff from John F. Kennedy International Airport in New York, resulting in 230 fatalities. The accident investigation conducted by the National Transportation Safety Board (NTSB/AAR-00/03) indicated that the centre wing fuel tank (CWT) exploded due to an unknown ignition source. However, of the ignition sources evaluated by the investigation, the most likely cause was a short circuit outside of the CWT that allowed excessive voltage to enter it through electrical wiring associated with the fuel quantity indication system.

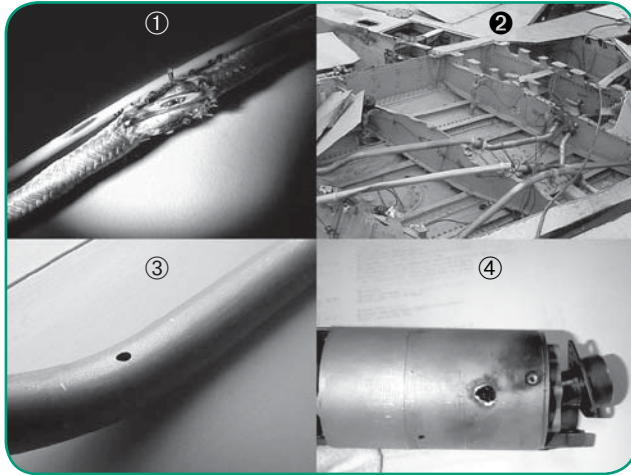
Photos courtesy of FAA SFAR 88 Workshop, June 2001:  
Potential ignition sources discovered by fleet inspection.  
1. Frayed fuel pump wire; 2. Main tank over pressure;  
3. Arc through conduit; 4. Arc through pump housing.

It should be noted that the SR flight 111 occurrence aircraft was manufactured in 1991, and therefore, should not be considered an aged airplane. In addition, a historical review conducted by the FAA of fuel tank explosions prior to the TWA flight 800 accident revealed that ageing was not the only contributing factor in the development of potential ignition sources. In particular, in May 1990, the centre wing tank of a Boeing 737-300 exploded during push back from a terminal gate prior

to flight, as the result of an unknown electrical ignition source; the aircraft was less than a year old. Hence, the development of such failures may be related to both the design and maintenance of the airplane systems.

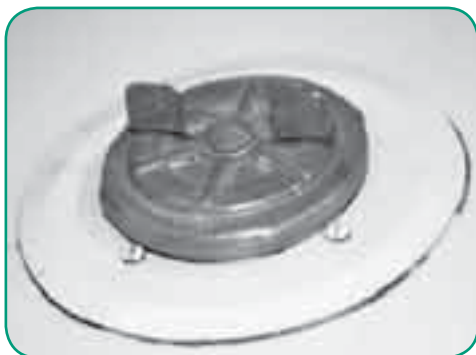
Figure 1: Non-probed fuel cap

The caps used on the occurrence aircraft, shown in Figure 1, had been ordered by the previous owner to replace the original caps to which a ram air probe is fitted to assure positive pressure within the fuel tanks (Figure 2). The order voucher indicated that non-leaking caps (non-probed caps) were requested. This was desired partly for aesthetic reasons and also because probed caps allowed fuel to leak out if the aircraft when it was parked on uneven ground. The order voucher included the aircraft serial number. The manufacturer forwarded the non-probed fuel caps without challenging whether the aircraft fuel system was original or it had been modified with auxiliary wing tanks. While the probed caps assure a positive pressure inside the fuel tanks, the air passage through the non-probed caps reduces the pressure within the tank below that of the ambient pressure.

After the most recent occurrence, the owner was prompted to verify the adequacy of the venting system, which is done through the fuel caps (Figure 1). Air passage on the left fuel cap was found to be erratic; sometimes it would let the air through, but sometimes it would not. Information from the manufacturer indicates that this type of cap is only to be installed on aircraft having been modified with auxiliary wing tanks (located outboard on the wings), as the modification includes the plumbing for a different venting system.
